Subject to change without notice.  
Leaflet No. 439 · 07.18 · e · L+S · VM3  
LEB00006-00

# Crankshaft Heat Treatment

## MaK Repair Intelligence

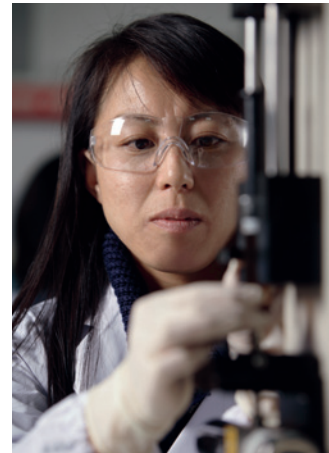
**Progressive material tests are important components of our safety standards.**
